TANITA EU – How to reattach the swivel of the DC-360 communication cable

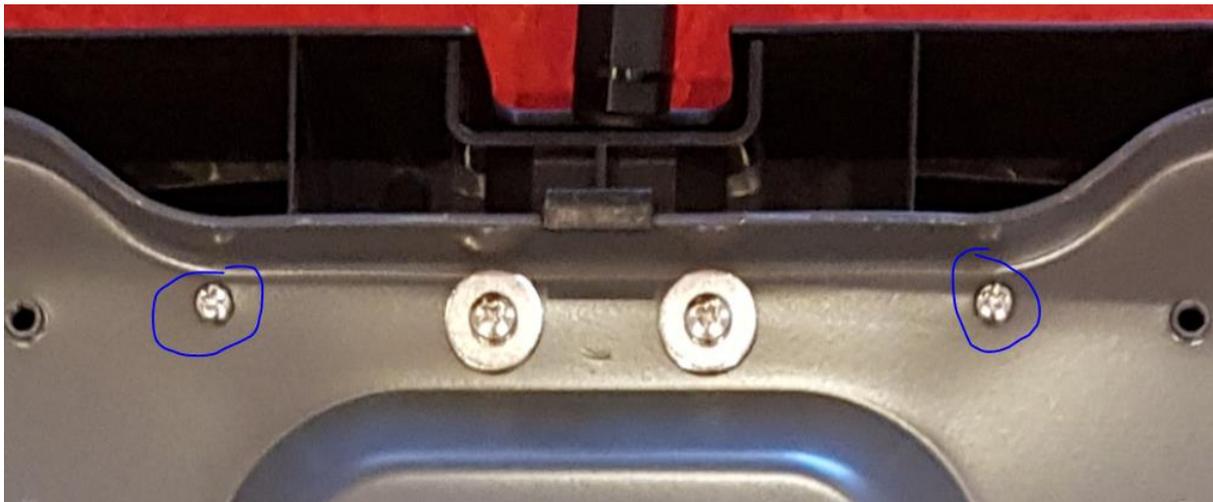
- 1) Turn DC-360 off and unplug the power cord.
- 2) Carefully turn the weighing platform over and place it upside down (on a soft cloth or else on a smooth and sand-free surface to avoid damage and scratches).
- 3) Using a screwdriver, unscrew the two outer screws (circled in blue in the photo below).
- 4) Turn platform over and click off the front part of the cover (sometimes this is a bit stuck, on the sides you can unclip it).
- 5) Tighten the swivel around the wire so that the wire is firmly back in place and attached to the platform.
- 6) Place cover back.
- 7) Tighten screws back into place.
- 8) Turn over the platform, plug in and switch on DC-360 and check if it works properly now.
